August 2008 Unit 2 Transformer Failure
Susan Westcott
Engineering Director
10/07/08

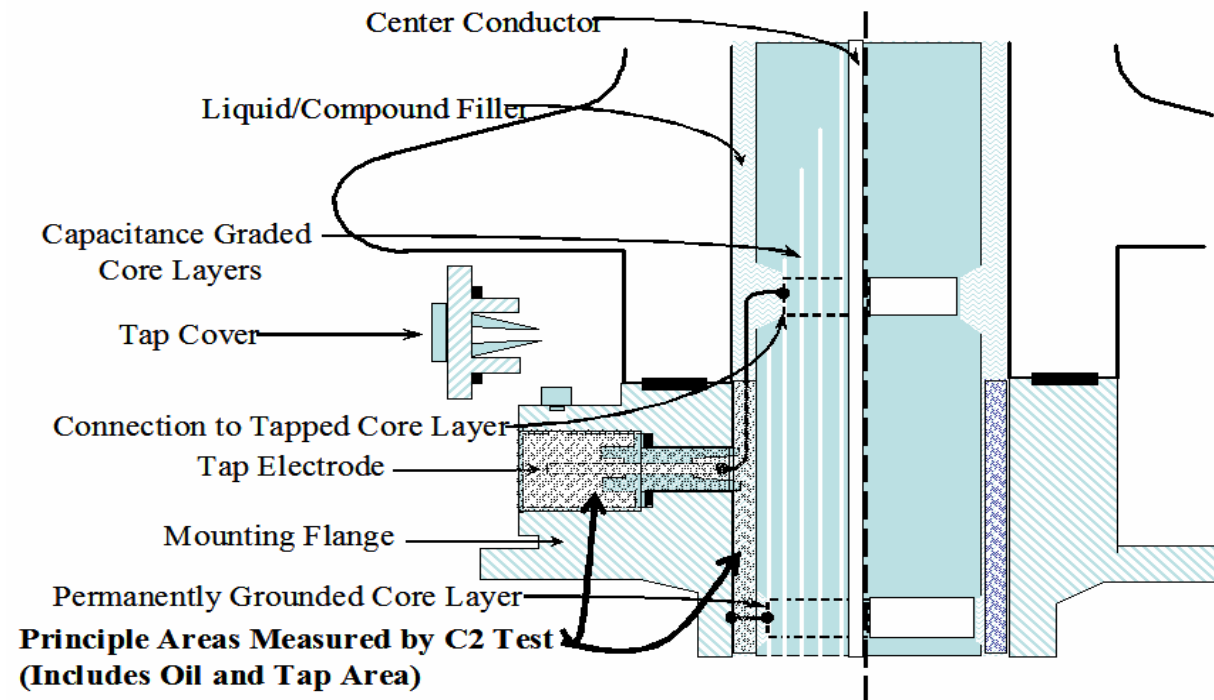
Typical Bushing Potential Tap Construction

- The preliminary cause investigation determined that the event was the result a phase to ground fault at the “C” phase main bank transformer high voltage bushing.
- A root cause analysis is underway to determine the cause of the bushing failure.
- The root cause analysis will identify the cause of the bushing failure as well as any additional corrective actions to prevent recurrence. These corrective actions will also address similar equipment that might be susceptible to the same failure mechanism.

- The root cause analysis has focused the potential causes to:
 - Degraded ground on the HV Bushing Test Tap
 - Low Bushing oil level
 - Paper degradation / thermal aging
 - Bushing oil quality.
- The bushing monitoring system installed during the 2T15 forced outage is effective at early identification for any of these potential causes or changes in the bushing insulating system.
- Other extent of condition corrective actions (i.e. enhanced performance monitoring, addition bushing monitoring systems, maintenance frequency changes) are currently being developed.

- The following corrective actions were taken to address the preliminary cause and prevent recurrence of the event:
 - Replace Unit 2 "C" Phase transformer
 - Test Unit 2 "A" and "B" transformers (including bushings), all lightning arresters, and all Capacitor Coupled Voltage Transformers (CCVTs).
 - Verify oil levels in all 3 main bank high voltage bushings.
 - Install on-line bushing monitoring system on Unit 2 Main Bank HV Bushings.
 - Clean and re-grease all 500 kV transformers, CCVTs, and lightning arrester porcelain insulators.
 - Add high voltage bushing oil level inspection to daily operator rounds.
 - Sample and test oil from "A" and "B" bushings.
- These corrective actions provided validation that the remaining high voltage bushings were in good condition and provides a means to determine if this condition changes.
